Reference no	PLN-25-0216
Site	658 WOOLMERS LANE LONGFORD
Proposed Development	Partial change of use - Visitor Accommodation
Zone	21.0 Agriculture
Use class	Visitor Accommodation

Change of use to visitor accomodation, internal fitout.

'Woolmers Cottages' 658 Woolmers Lane, Longford

PROJECT
WOOLMERS COTTAGE
WOOLMERS FOUNDATION INC.
WOOLMERS LANE, LONGFORD, TASMANIA, 7301
country of the Panninher people of the Northern Midlands nation, Lutruwita

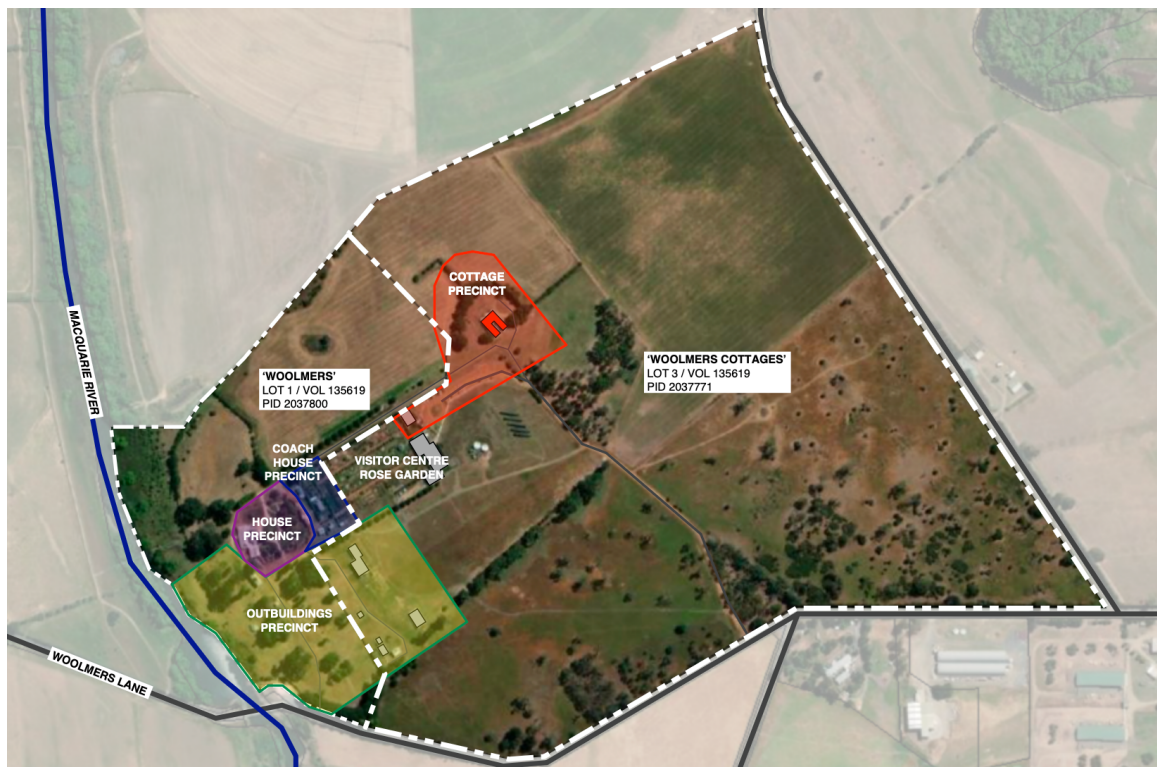
Figure 1: Site plan of Woolmers Estate. Diagram by author.

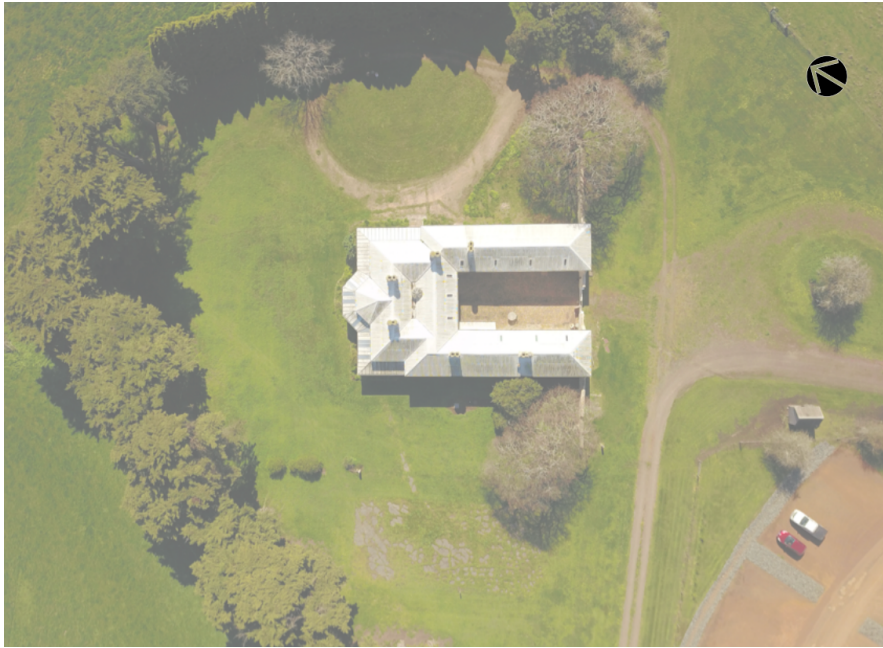
Figure 2: Woolmers Cottage, illustrating curved tree line to north-east and north-west, and modern Woolmers visitor center carpark in bottom right. Photograph taken by Darren Watton, September 2022.

A circular driveway, surfaced with white pebbles and edged with bricks likely produced on the Estate, remains evident and continues to define the formal setting of the cottage. To the rear, a cobbled service courtyard is enclosed by the coach house, stable and tack rooms, and the service wing, which accommodates the kitchen, scullery, and several ancillary spaces. The foundations of a former tennis court remain to the south-west of the cottage (**Figure 2**).

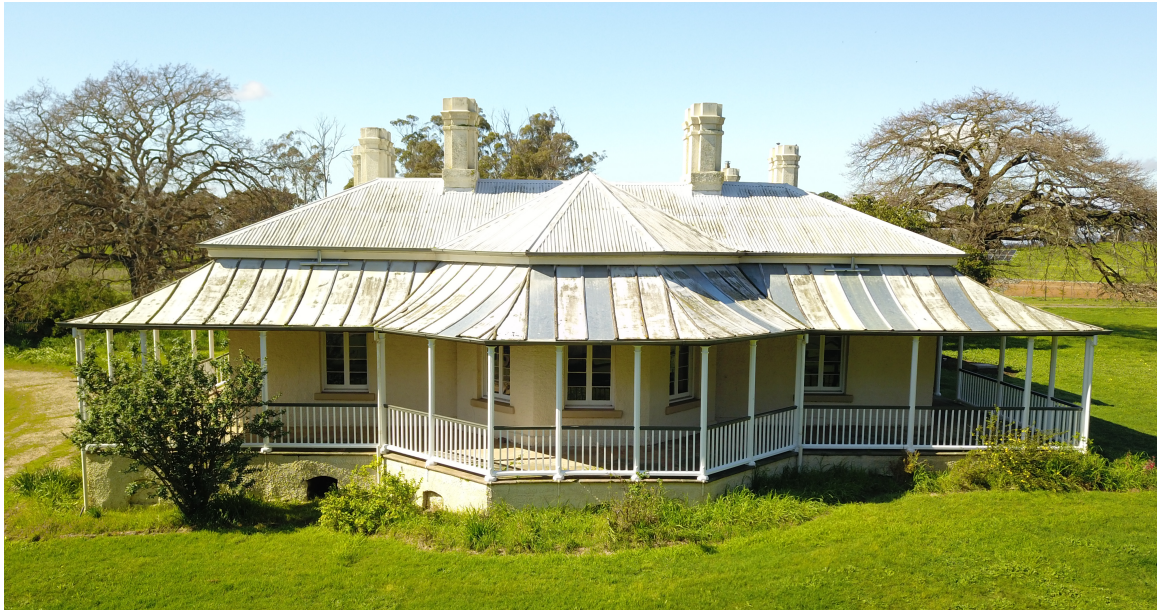
Following restoration works in 2006 and 2011, Woolmers Cottage retains much of its external fabric, although the remnants of the formal garden have been lost (**Figure 9**).

Figure 9: Woolmers Cottage from the north-west. Photograph taken by Darren Watton, September 2022.

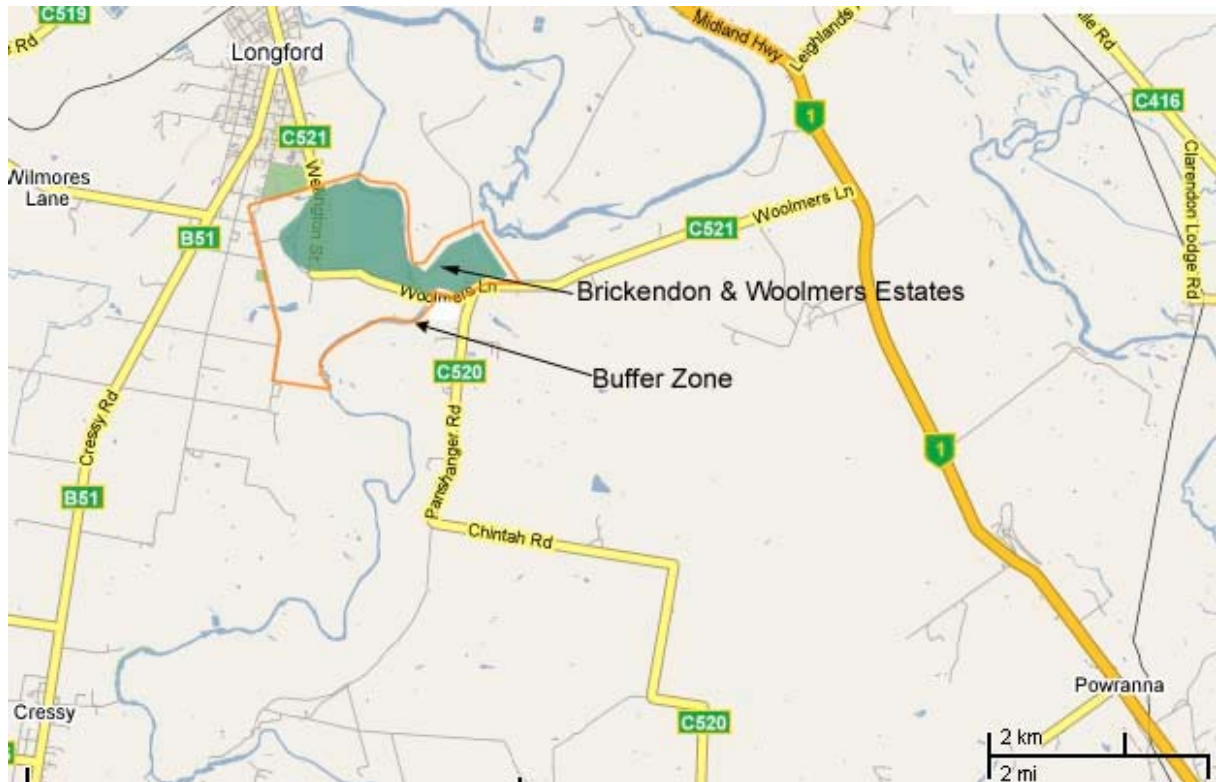
Figure 7. 1: Identification of the recommended buffer zone (outlined in orange) for the areas of the Brickendon and Woolmers Estates which will be nominated for the World Heritage List (shaded in green).

Policy 6: A buffer zone should be identified as in Figure 7. 1

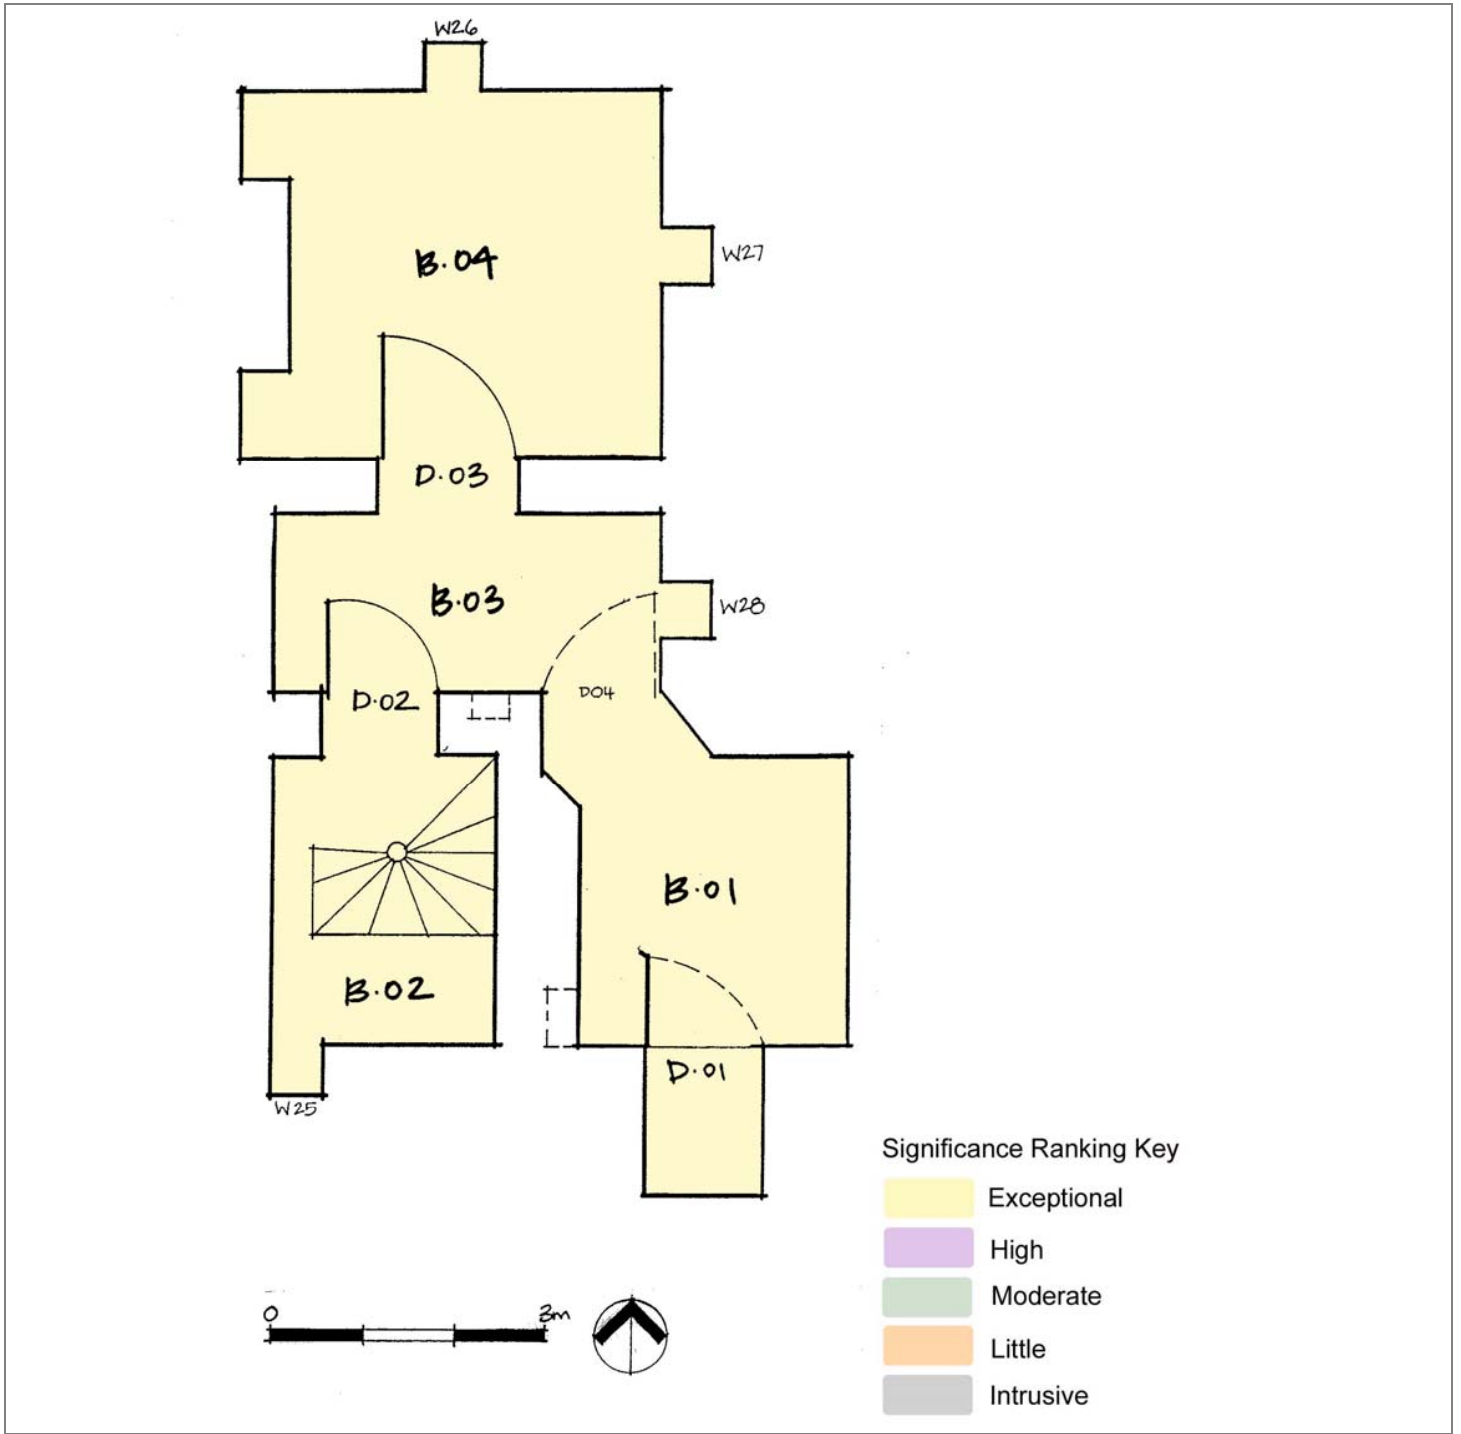
Basement plan of Woolmers Cottage showing significance ranking of interior spaces

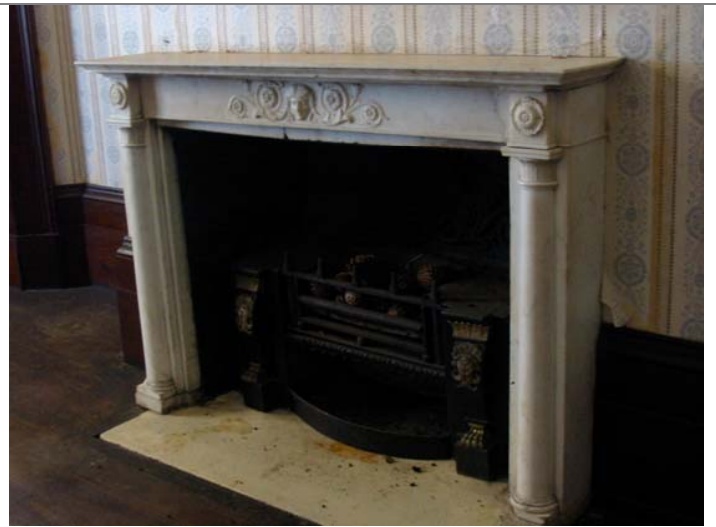
Cararra marble Neo Classical chimneypiece in Drawing Room (Space G09)

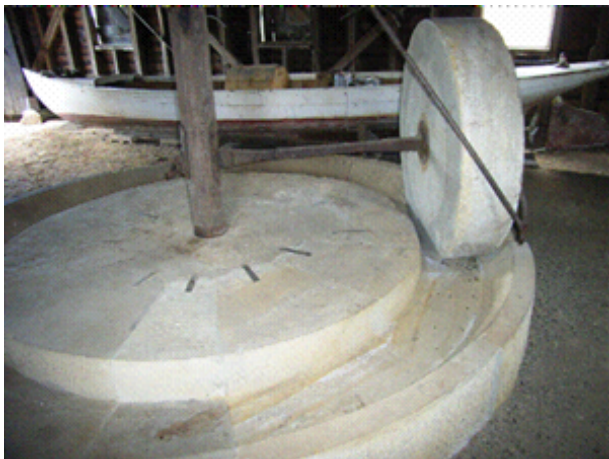
Horse-driven apple-crusher in the Cider House.
DEPHA

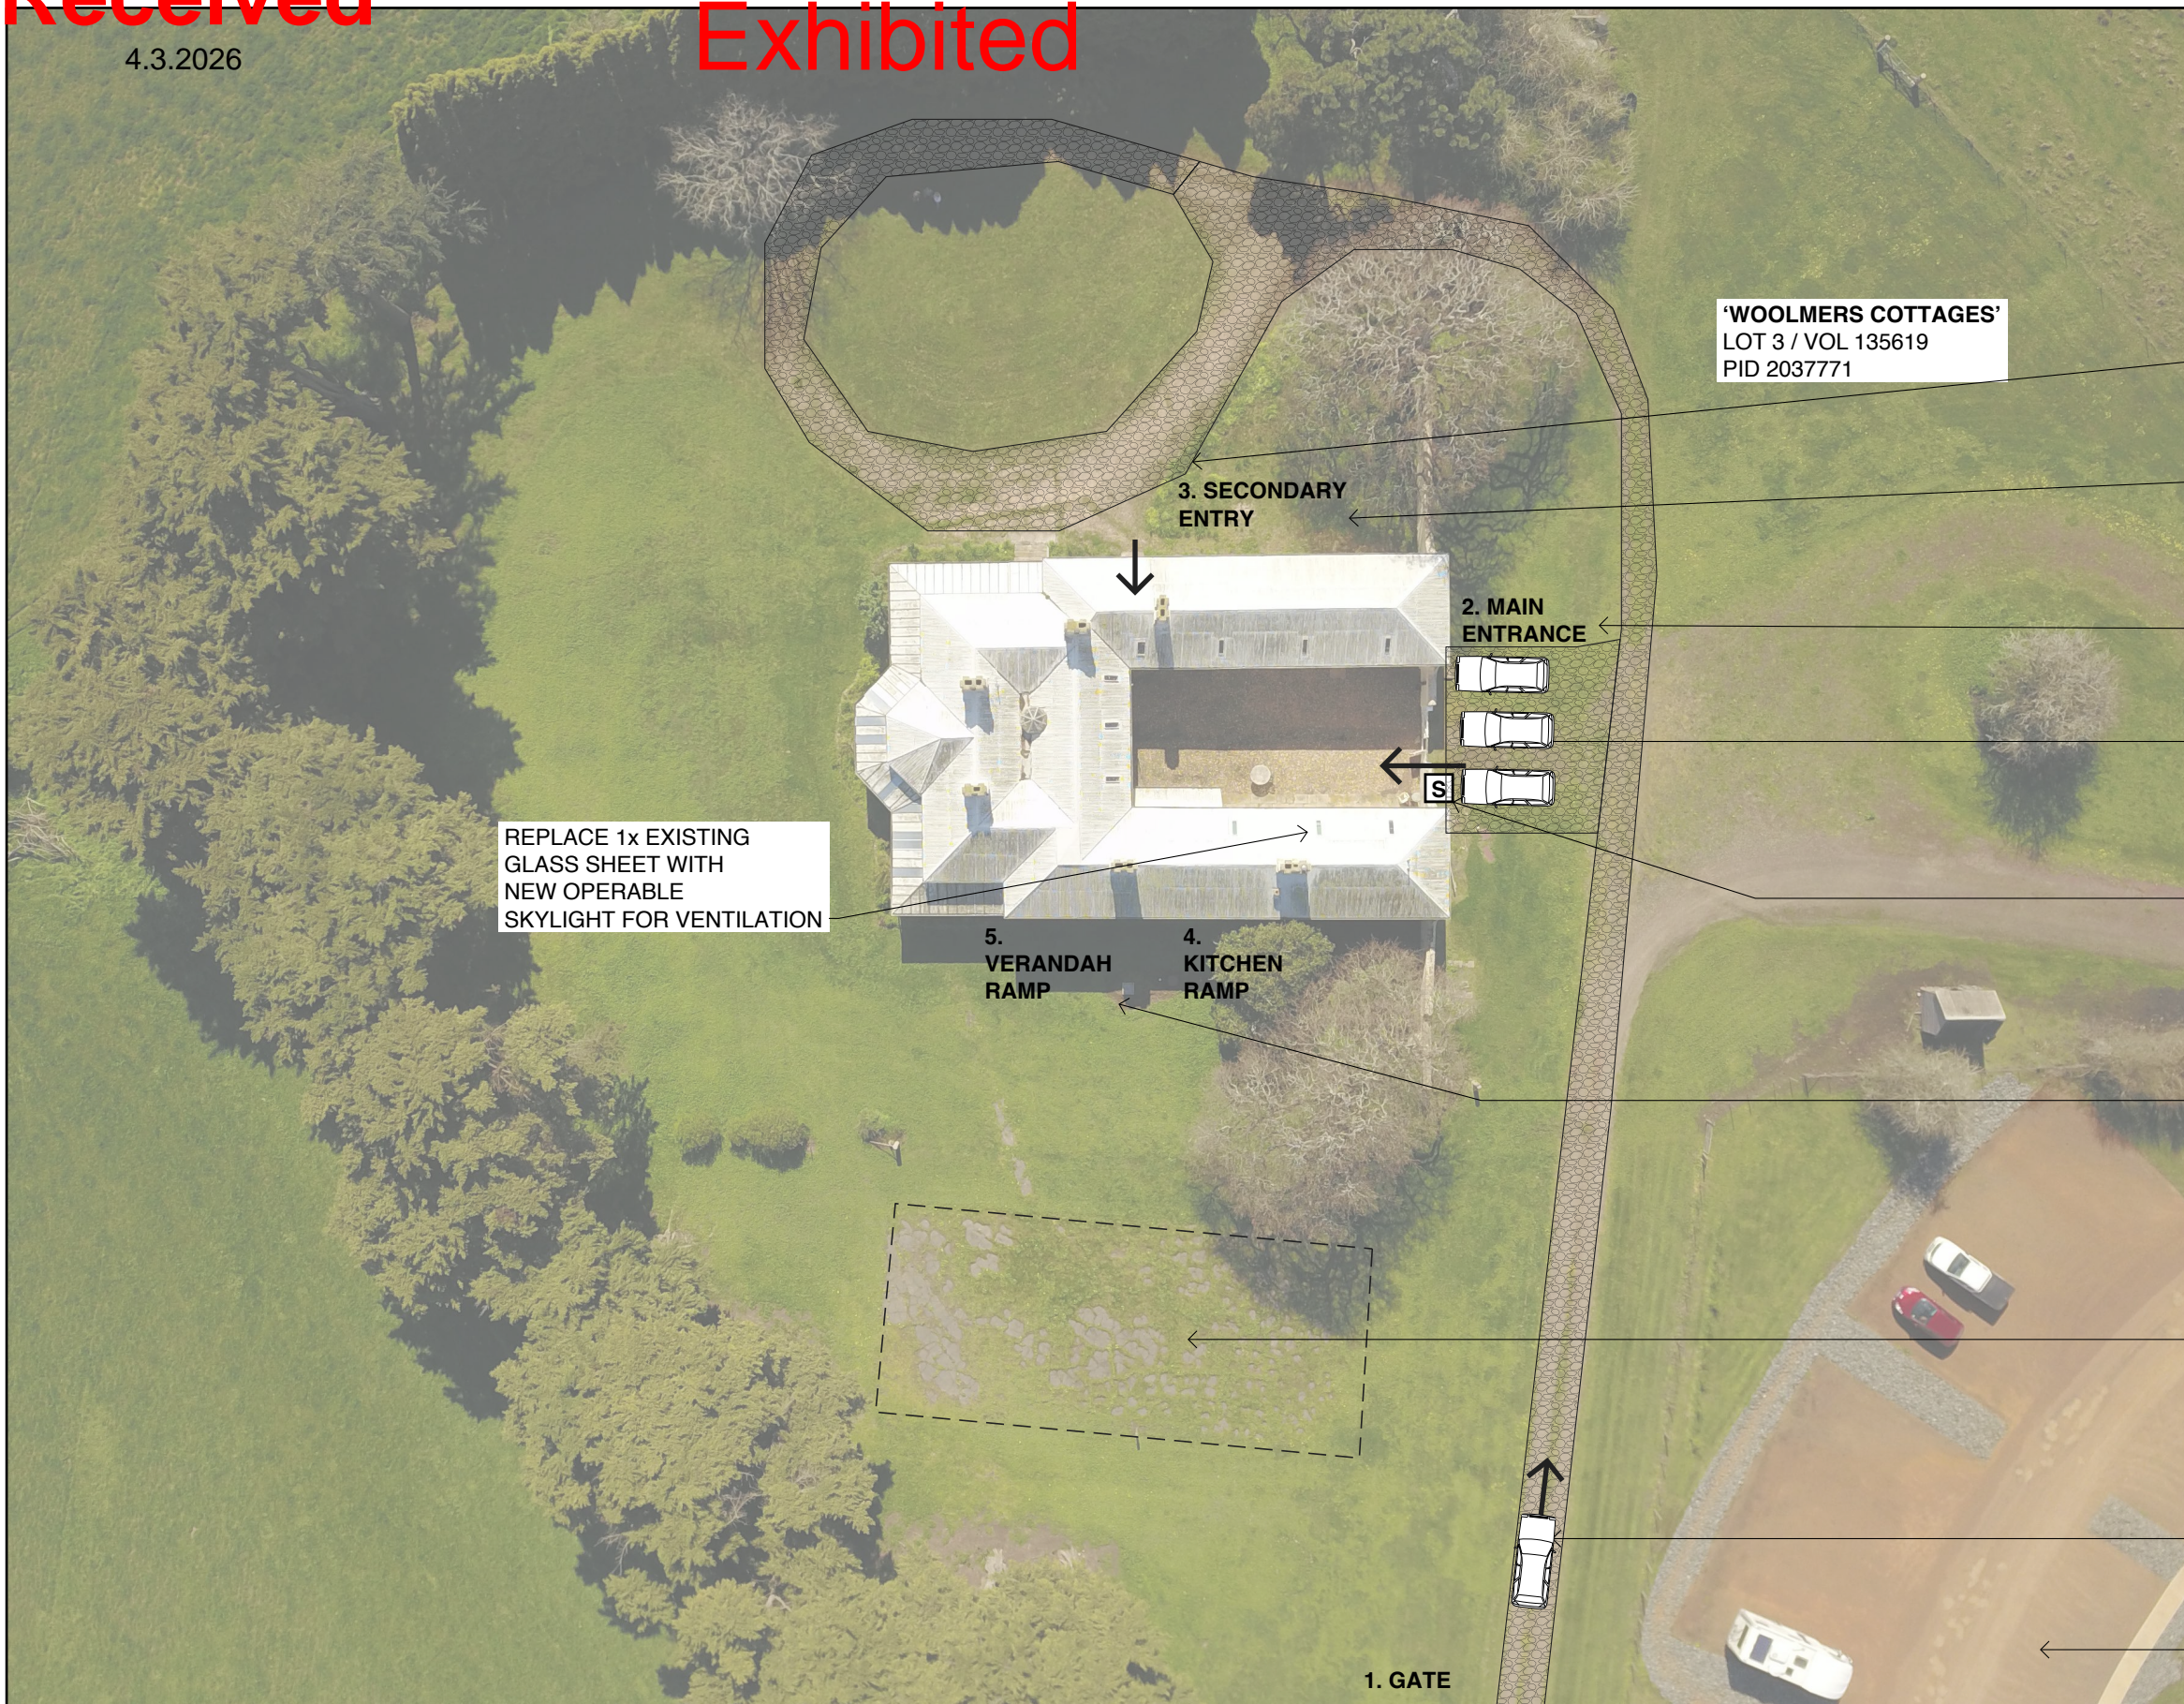
TRUE NORTH
DRAWING NO.
35724_100

REPLACE 1x EXISTING
 GLASS SHEET WITH
 NEW OPERABLE
 SKYLIGHT FOR VENTILATION

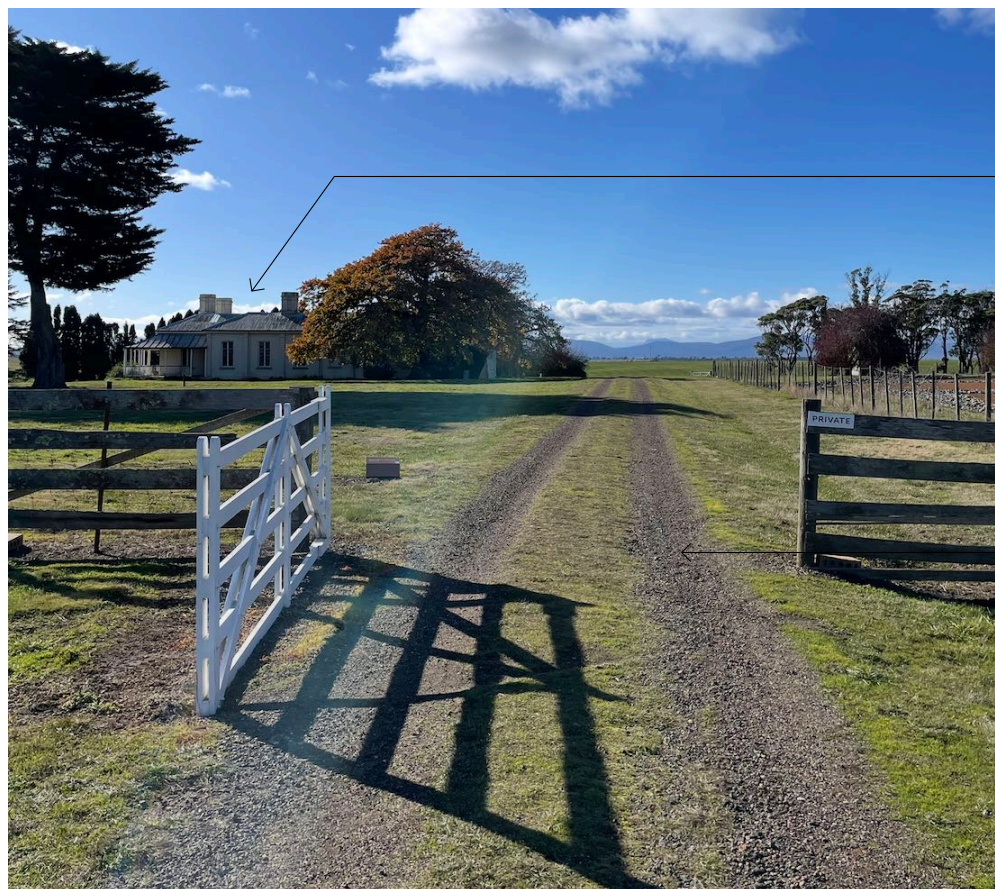
1. GATE - ENTRANCE TO WOOLMERS COTTAGE

PROVIDE ADDITIONAL GRAVEL TO EXISTING GRAVEL WHEEL STRIPS. WHERE BRICK EDGING PRESENT, HAND WEED AND TAKE CARE WHEN TOPPING UP GRAVEL TO RETAIN IN SITU.

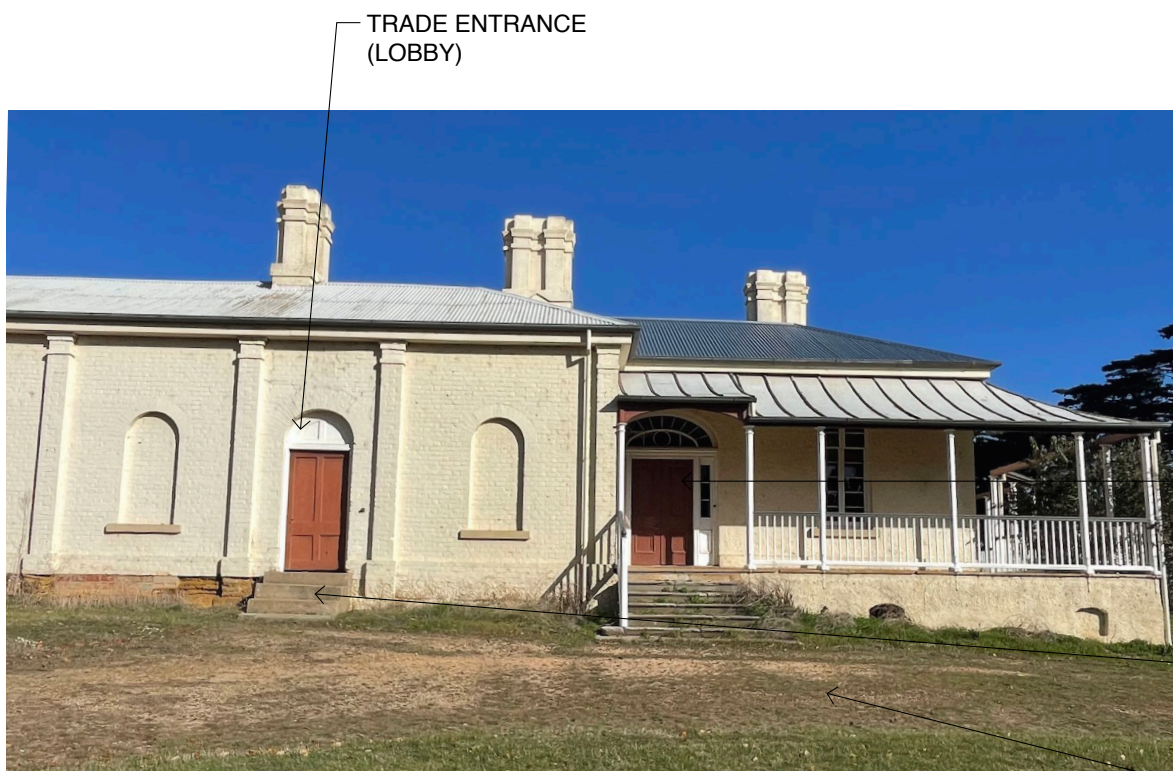
4. KITCHEN RAMP

NEW RAMP PROPOSED TO ACCESS COMMERCIAL KITCHEN

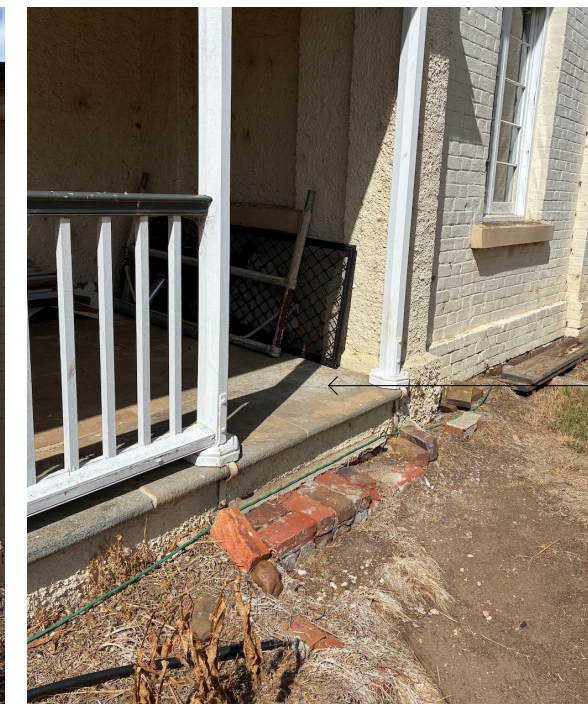
5. VERANDAH RAMP

NEW DDA RAMP PROPOSED TO ACCESS VERANDAH

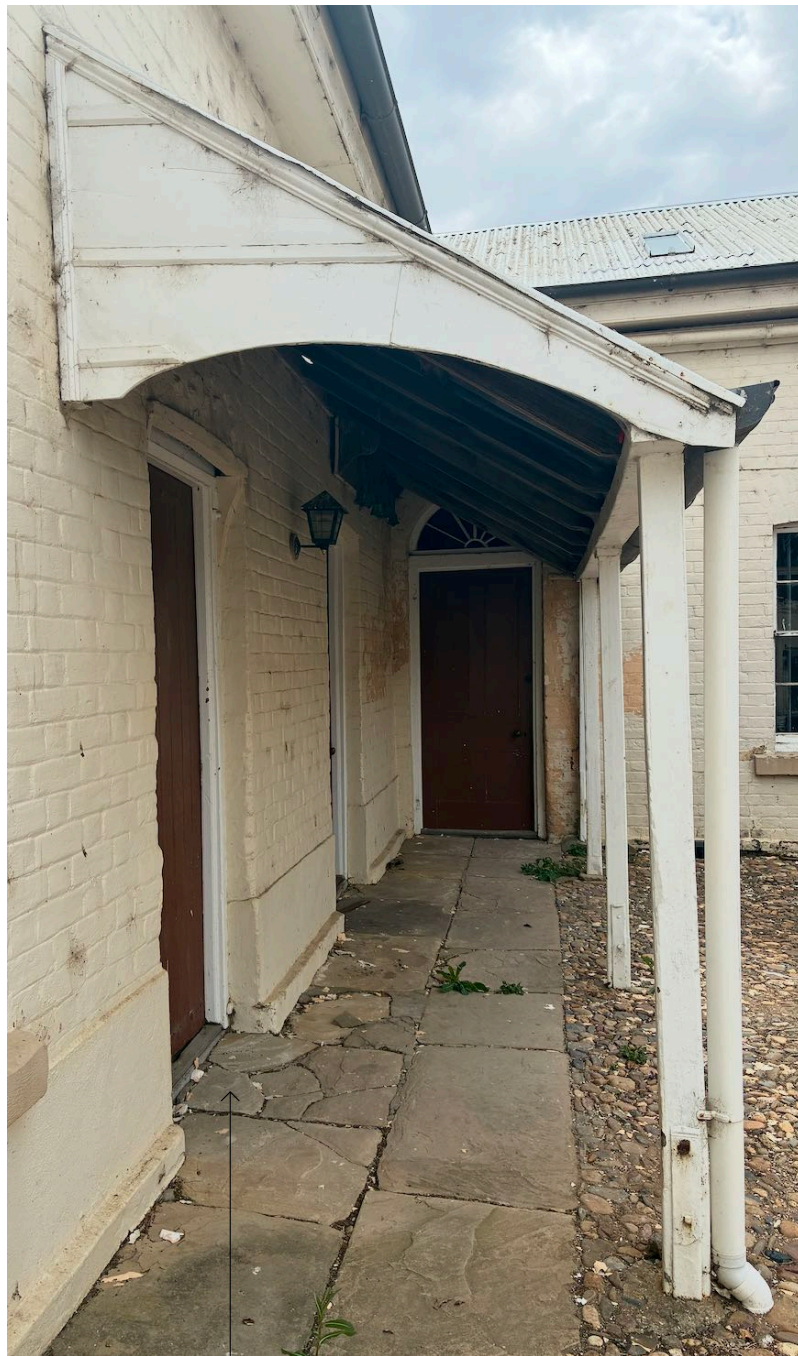
DRAWING NO.
35724_104

CHASE NEW FLASHINGS INTO BRICKWORK TO FLASH TOP OF GALVANISED SHEET (CURRENTLY OPEN AND LETTING IN WATER).

REMOVE OVERSIZED LOOSE FLASHING. REPLACE WITH CHASED FLASHING FOLLOWING BRICKWORK.

ROTTEN RAFTERS ENDS TO BE SCARFED AND REATTACHED

ROTTING POST TO BE REPAIRED AND REATTACHED TO FRAMING

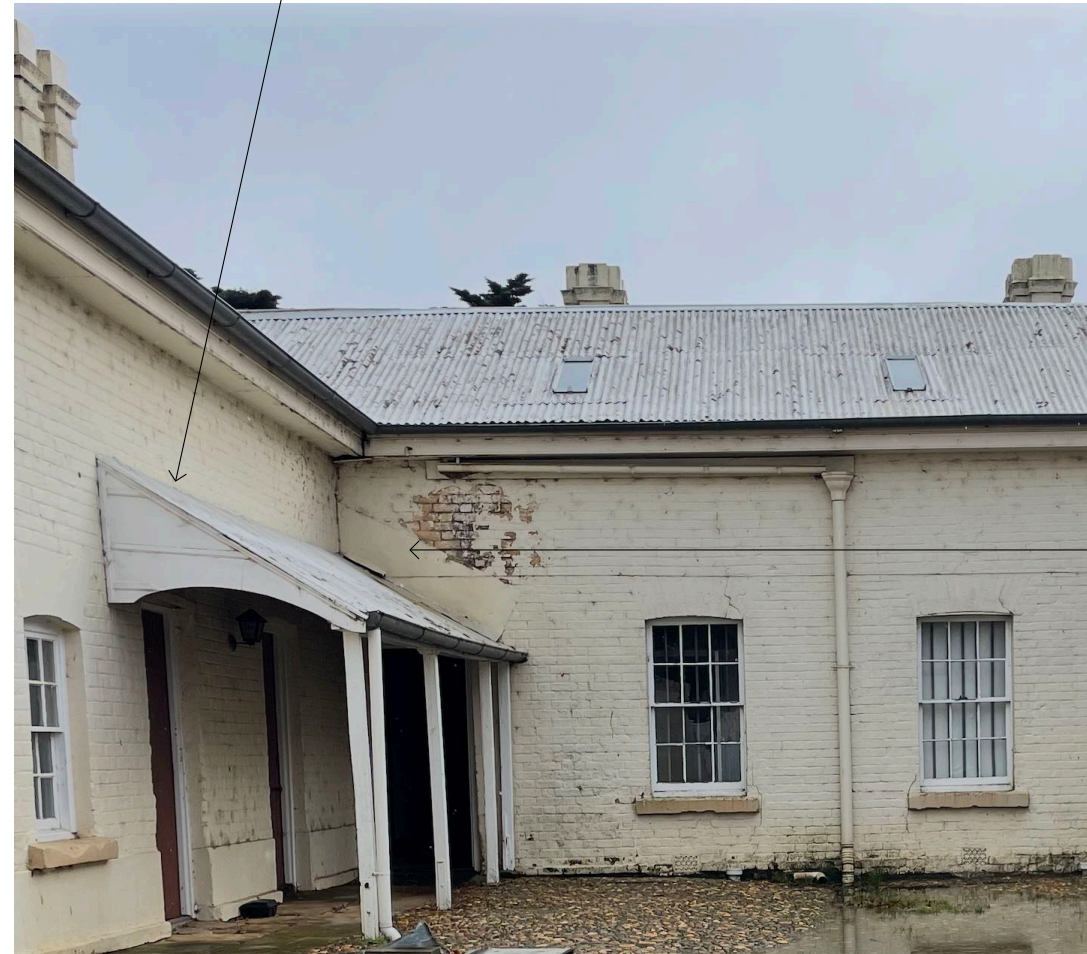
REPAIR OR REPLACE SEVERLEY CRACKED AND UNEVEN PAVERS (TOTAL OF 2)

CAREFULLY REMOVE CONCRETE MORTAR AND REPLACE WITH LIME MORTAR

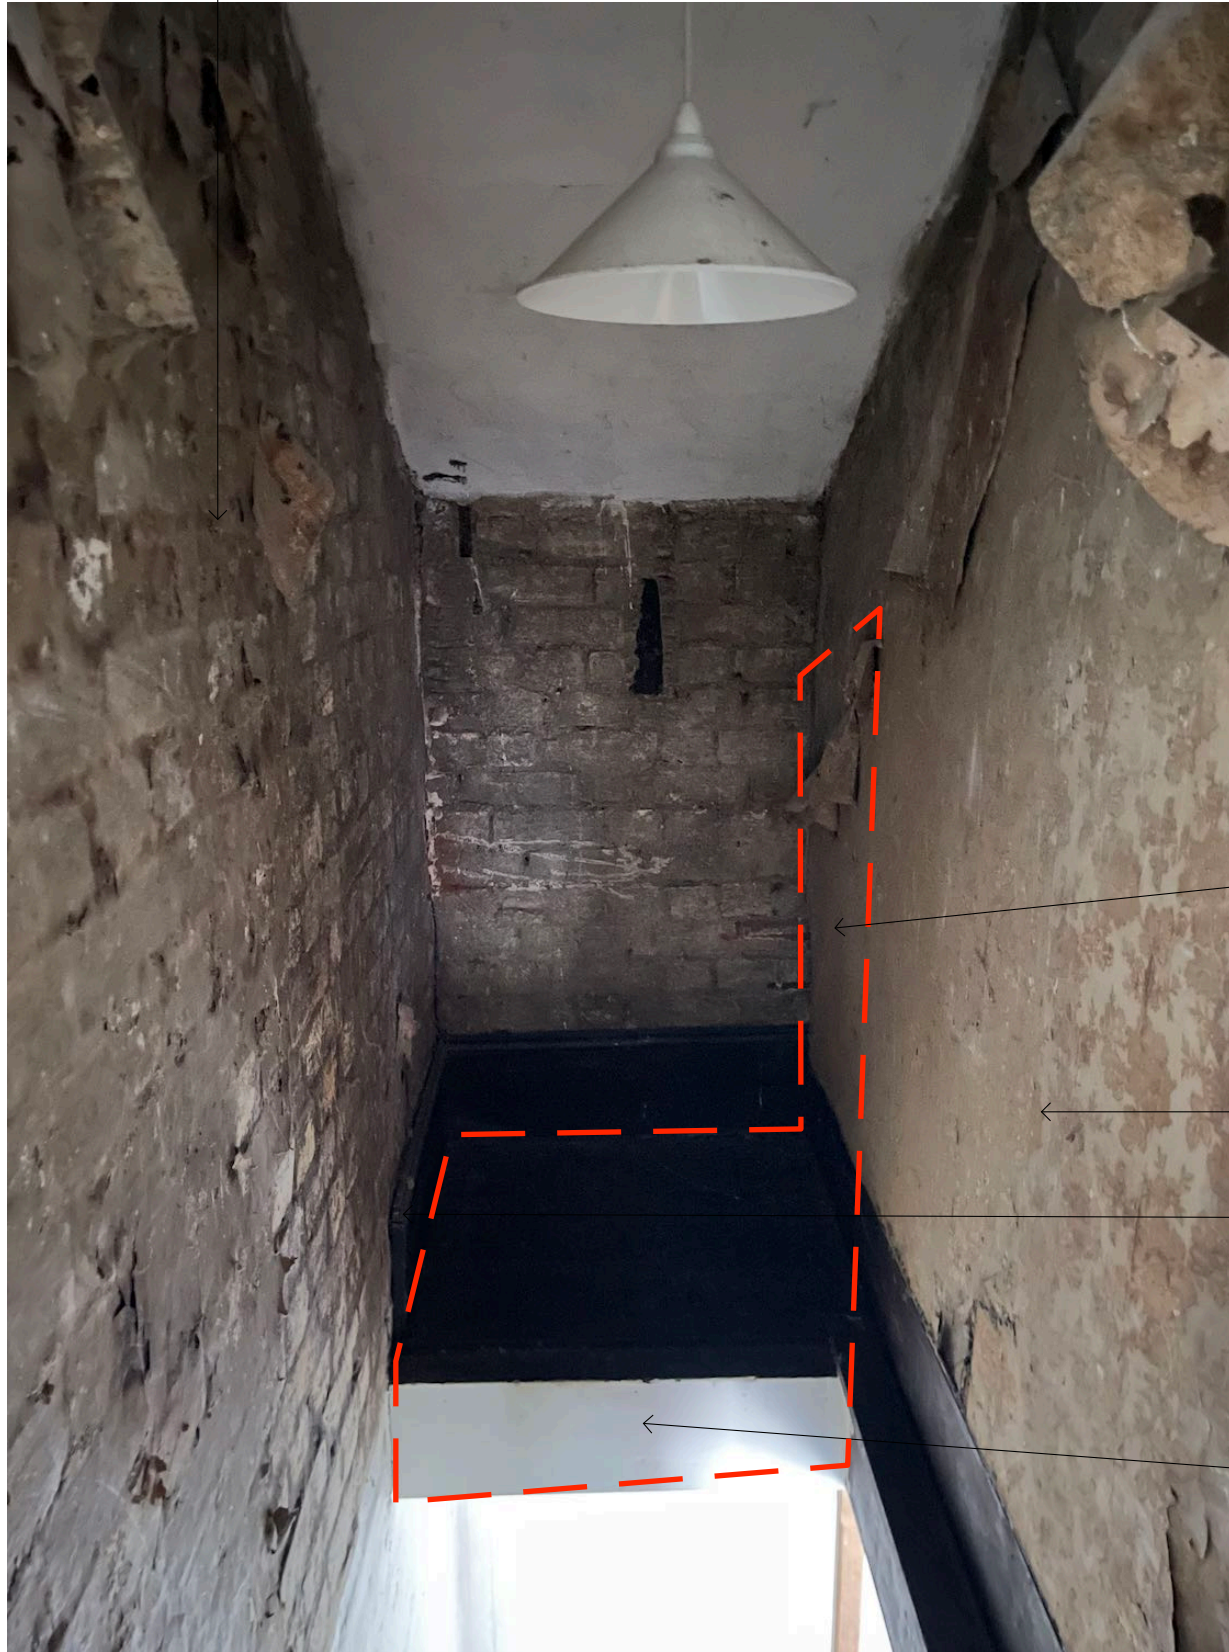
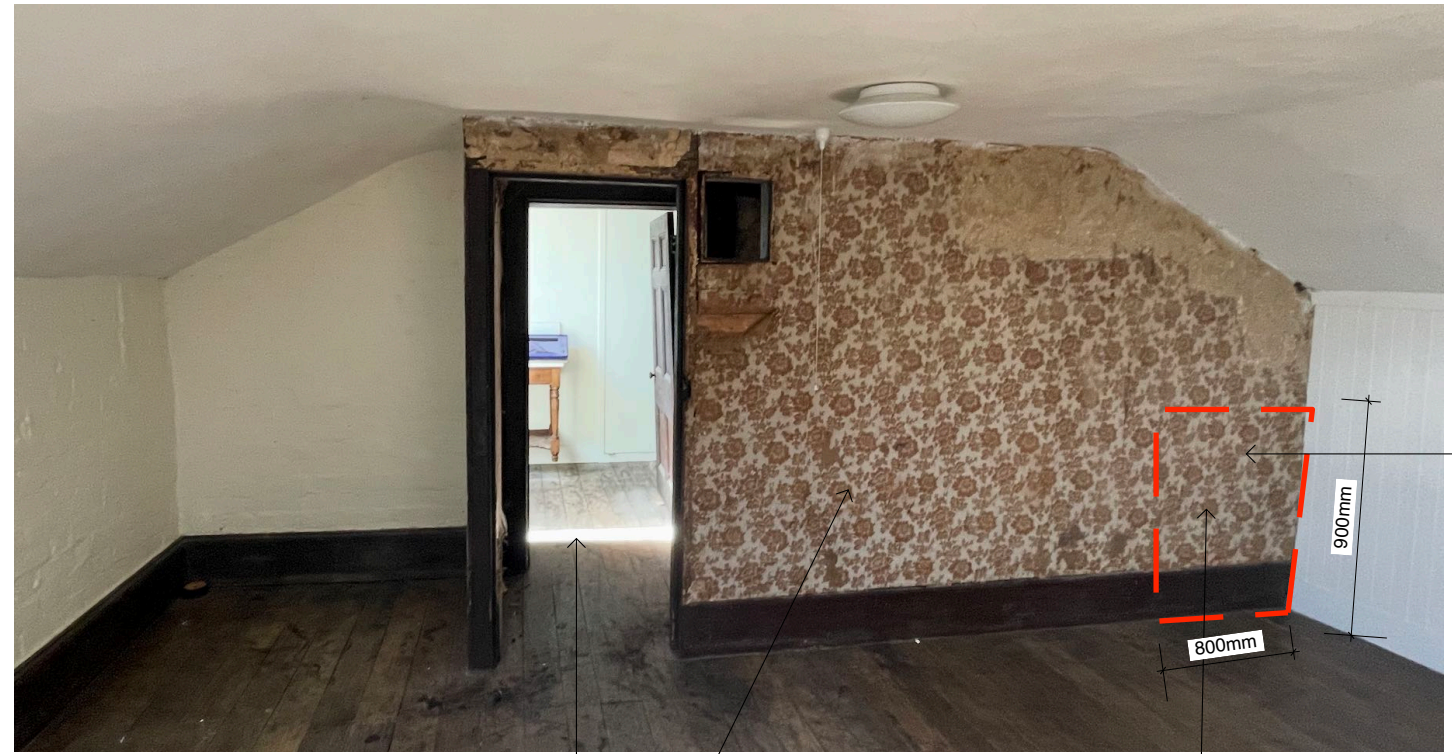
NO NEW FINISH
TO EXISTING WALL

REMOVE WALL
ONLY AS
REQUIRED
FOR HEAD
HEIGHT
CLEARANCE

ORIGINAL EXISTING
LANDING AND DOOR OPENING
INTO BATHROOM, LIMITED STAIRS
FROM EXTENDING IN THIS DIRECTION.

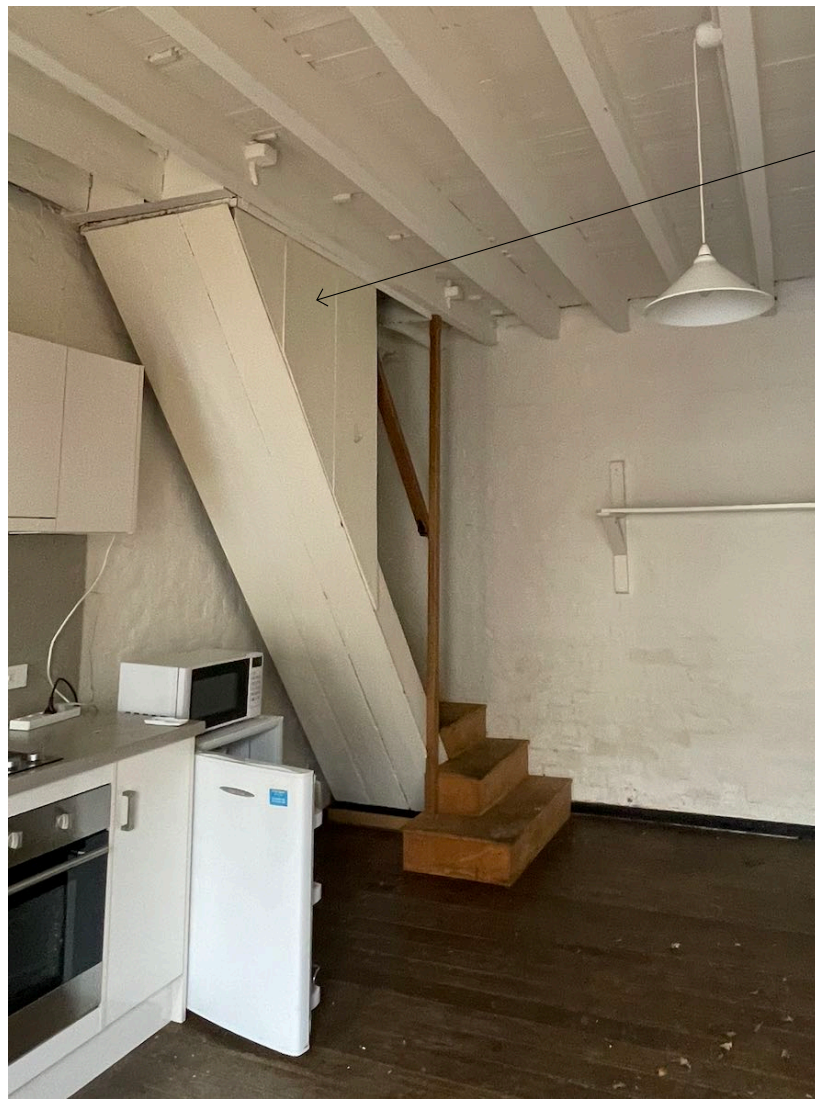
CARETAKERS UNIT ORIGINAL STAIRS. STAIRS HAVE DETERIORATED AND ARE NO LONGER SAFE TO USE. PROPOSED REMOVAL OF STAIRCASE, RETAIN INTACT AND HANG ON WALL.

The replacement of the original Caretakers Flat staircase is assessed as having a **high physical impact**, as it involves alteration to significant internal fabric, including portions of original floor structure and wall elements. However, this intervention is considered justified on the basis of safety, compliance, and sustainable occupation. The existing stair is structurally compromised and dangerously steep, preventing viable and safe use of the upper level. The proposed replacement enables compliant access while retaining removed significant fabric on site for interpretation. The works ensure the long-term functional viability of the building, consistent with Burra Charter Article 21, which supports adaptation necessary for compatible use.

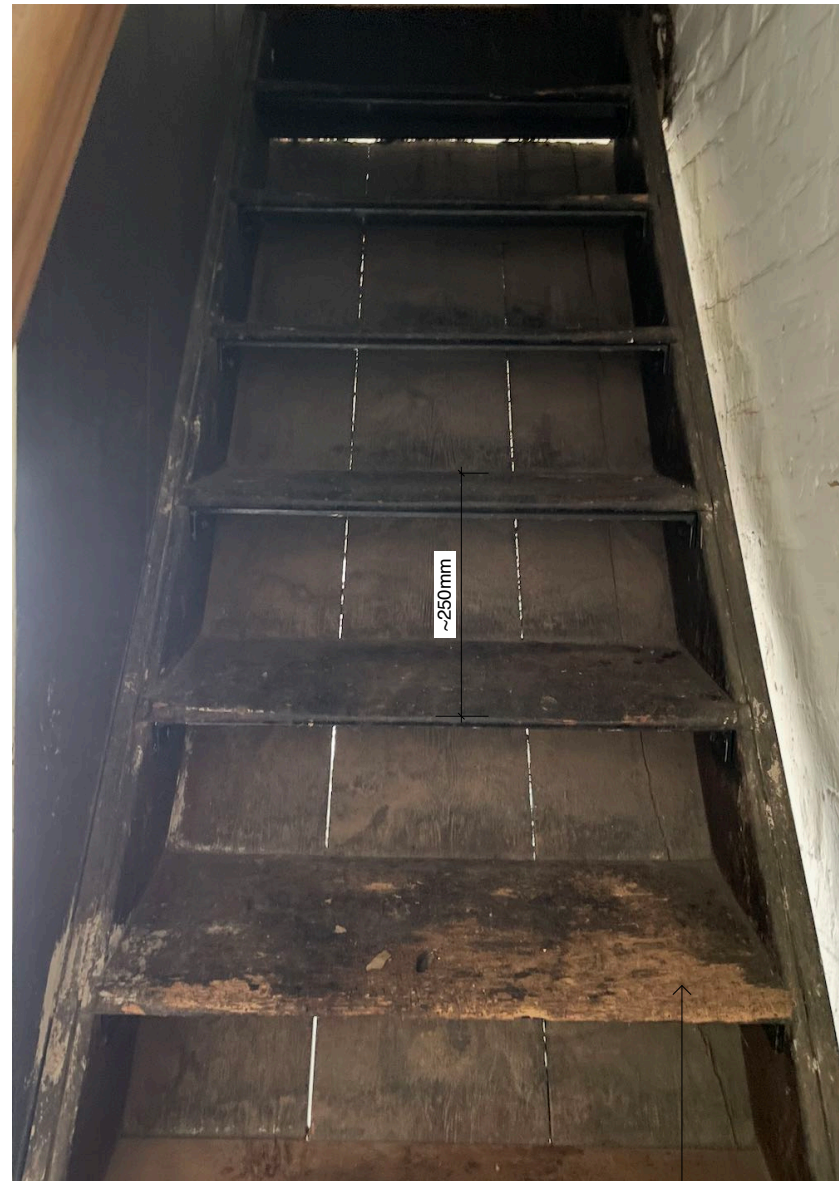
~250mm

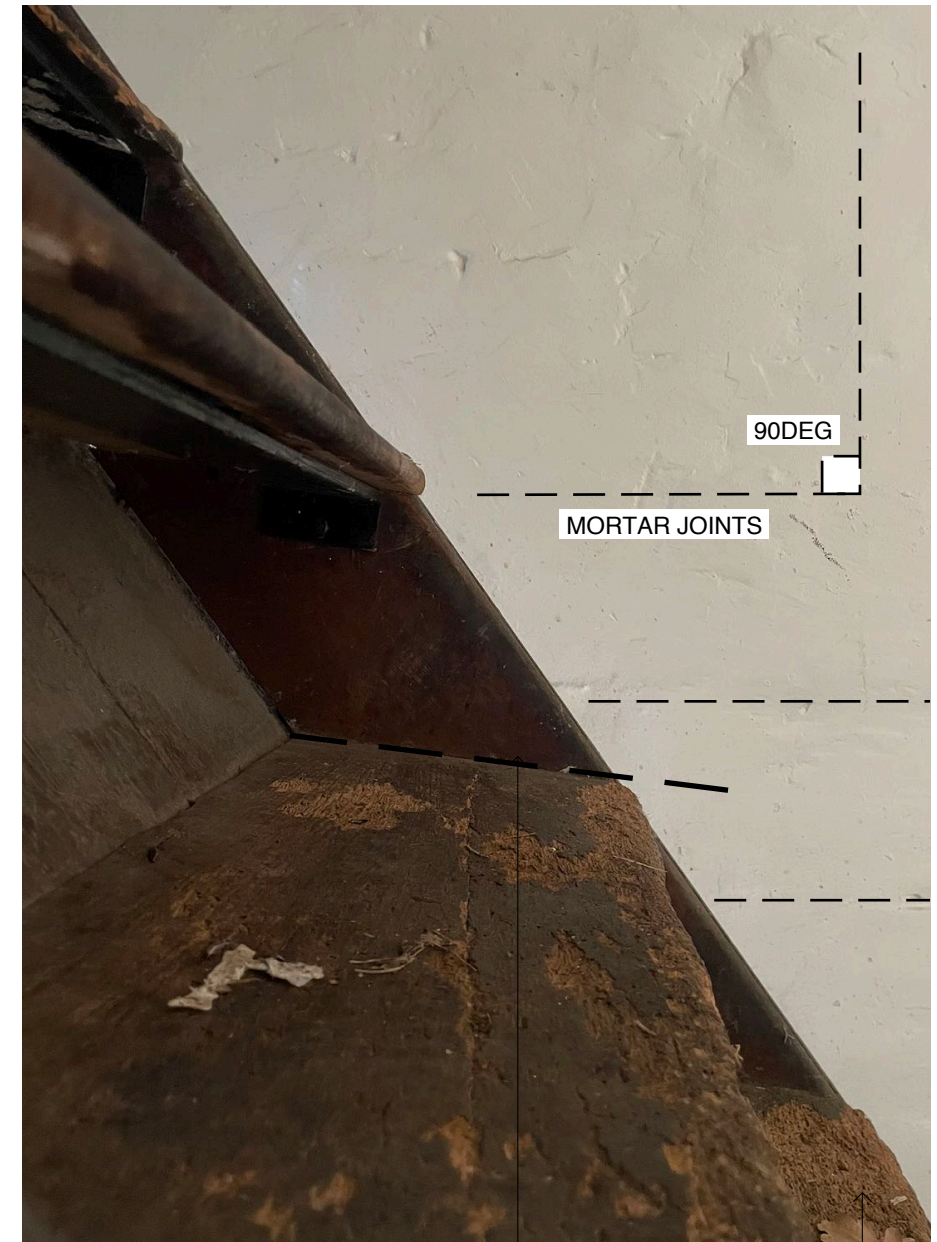
SIGNIFICANT DAMAGE TO EDGE OF STAIRS

SIGNIFICANT DAMAGE TO EDGE OF STAIRS THROUGHOUT MOST TREADS

NEW TIMBER STAIRS MAX RISE 190mm AND MIN WIDTH 240mm ENCLOSED STRINGER TYPE WITH VERTICAL TIMBER ENCLOSING UNDERSIDE TO MATCH EXISTING. STAIR TO BE STAINED IN DARK COLOUR.

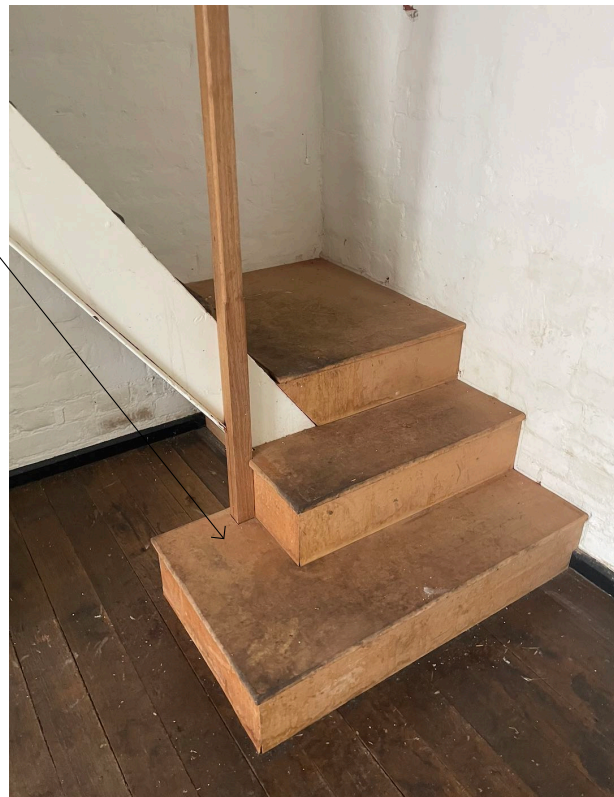
INDIVIDUAL TREADS HAVE A SIGNIFICANT SLOPE. STAIRS MUST BE USED BACKWARDS LIKE A LADDER.

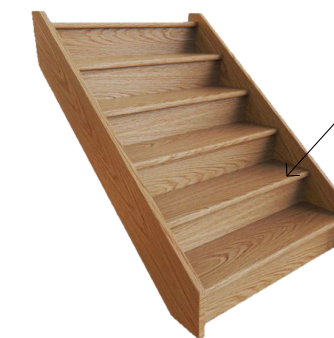
CLEAR NON-SLIP TAPE TO EDGE. STAIR NOSING.

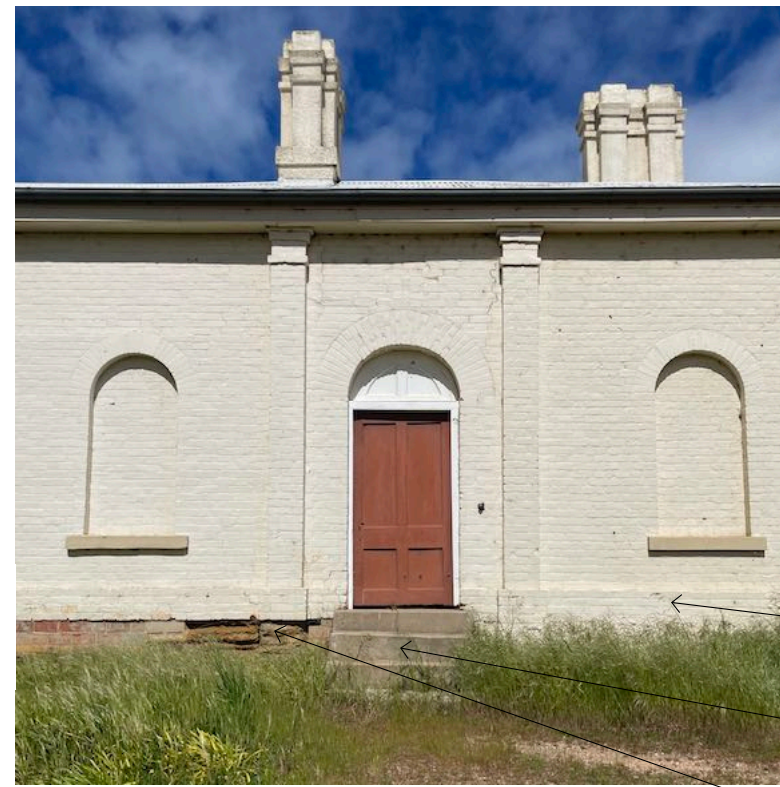
SCHEMATIC SECTION

EXISTING HARLING RENDER PLINTH

EXISTING CONCRETE OVER SUSPECTED BRICK STAIRS

EXISTING DAMAGED SANDSTONE PLINTH THAT HAS BEEN PATCHED WITH BRICK AND CONCRETE BLOCK

SANDSTONE PLINTH FOUNDATION IN POOR CONDITION. STONE REPAIRS TO PREVENT FURTHER DETERIORATION.

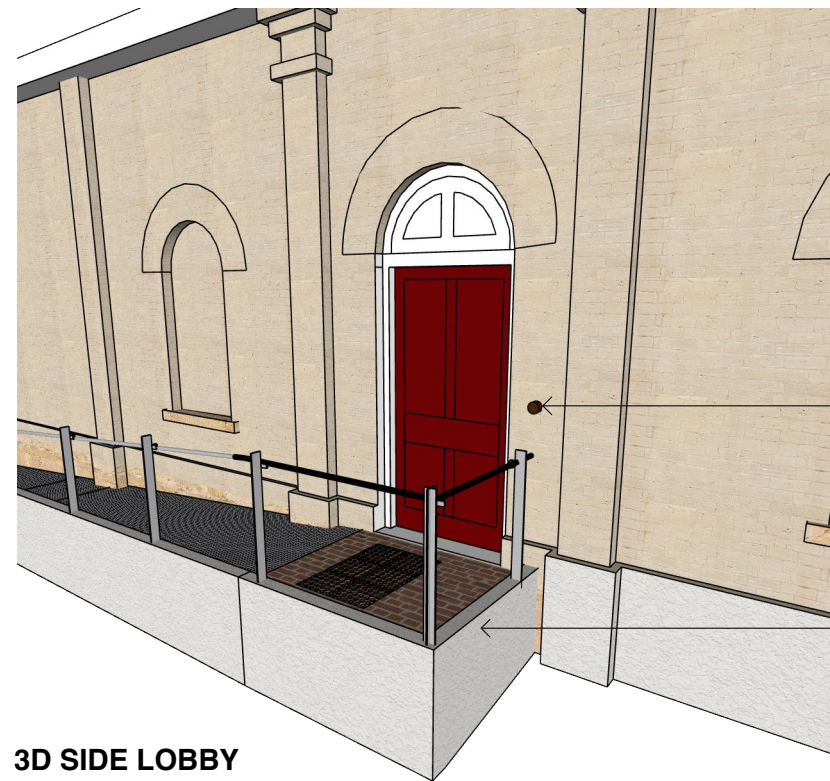
1
203
ELEVATION SIDE LOBBY
1:50

EXISTING HARLING RENDER PLINTH FOUNDATION (OVER SANDSTONE)

NEW PROPOSED HARLING RENDER OVER NEW BLOCK SUPPORTING WALL BEHIND, TO MATCH EXISTING COLOUR.

RETAIN AND REPAIR EXISTING DOORBELL

PLINTH SITS 65mm HIGHER THAN SURFACE TO ACT AS KERB
