Reference no	PLN-25-0216
Site	658 WOOLMERS LANE LONGFORD
Proposed Development	Partial change of use - Visitor Accommodation
Zone	21.0 Agriculture
Use class	Visitor Accommodation

Change of use to visitor accomodation, internal fitout.

'Woolmers Cottages' 658 Woolmers Lane, Longford

PROJECT
WOOLMERS COTTAGE
WOOLMERS FOUNDATION INC.
WOOLMERS LANE, LONGFORD, TASMANIA, 7301
country of the Panninher people of the Northern Midlands nation, Lutruwita

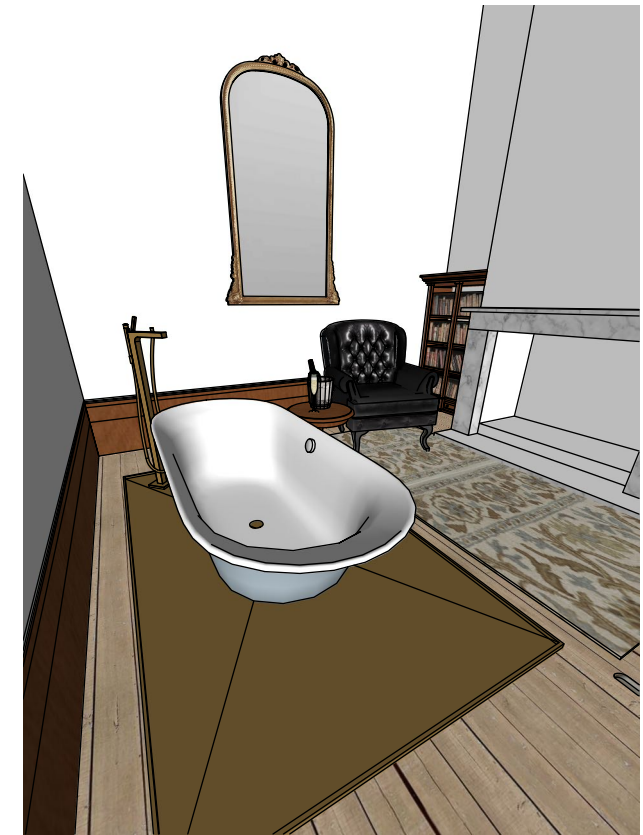
1 205
DETAIL PLAN - 'BATH' ROOM
1:20

NEW FREESTANDING BATH AND FLOOR MOUNTED MIXER TAP. FREESTANDING BATH TO BE SITUATED ABOVE FC SHEET, WITH METAL TRAY OVER FLOORBOARDS. PLUMBING TO RUN UNDERFLOOR IN THE BASEMENT, CONNECT TO ADJACENT WC PLUMBING.

RETAIN ALL EXISTING FEATURES WITHIN ROOM, INCLUDING FLOORBOARDS, FIREPLACE, HEARTH, SKIRTING ETC.

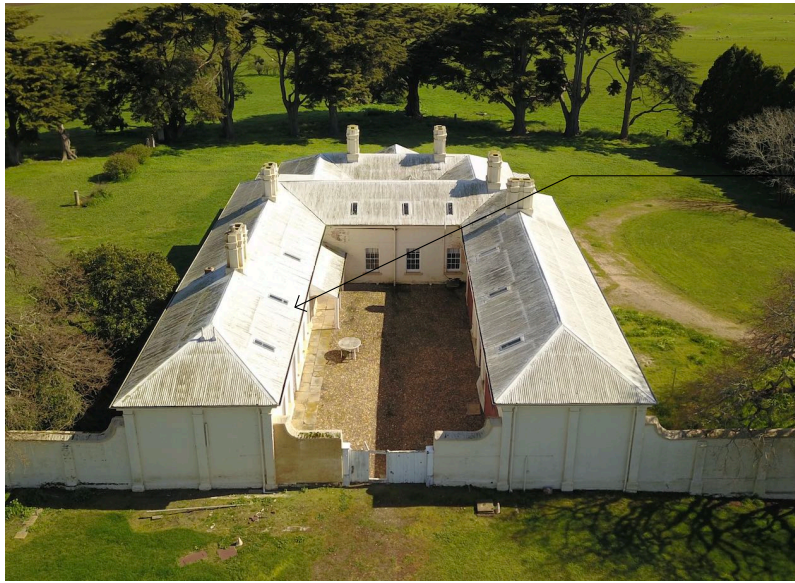
SCHEMATIC SECTION KITCHEN RAMP

REPLACE 1x EXISTING SHEET GLASS (MODERN GLASS) SKYLIGHT WITH OPERABLE VELUX SKYLIGHT.

EXISTING GALVANISED IRON SHEET ROOF HAS BEEN CUT INTO TIMBER EDGE (REPLACEMENT SHEET)
 EXISTING SHEET OF MODERN GLASS (NOTE GREEN TINGE ON EDGE)
 TOP OF TIMBER TO BE TRIMMED TO ALLOW FOR NEW SKYLIGHT TO SIT ON BATTENS
 EXISTING TIMBER TRIM TO BE RETAINED (NON-ORIGINAL FABRIC - SEE LEFT IMAGE OF C.2009)
 EXISTING LATH CEILING TO BE RETAINED
 EXISTING INTERNAL BRICK WALL IN BACKGROUND

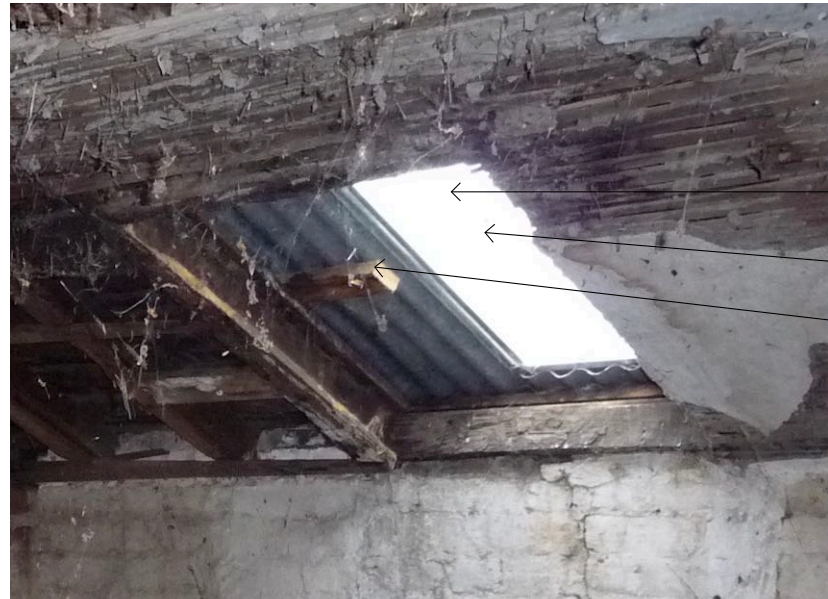
SKYLIGHT OPENING C.2009 DURING RENOVATION WORKS
 MODERN GLASS
 EXISTING BATTENS

Replace Skylight with Operable Velux (F.04)	Policy 3, 12, 36, 51, 57	The existing fixed glazed roof light is proposed to be replaced with an operable VELUX skylight to improve natural ventilation and reduce condensation risk within the upper level accommodation. The intervention does not alter the structural roof form, and the opening size remains consistent with the existing penetration. While there will be a minor visual change to external flashings, the skylight is located on a secondary roof plane that is not readily visible from primary public viewpoints. The works	Low Impact
